CRYSTAL DOWNS COUNTRY CLUB

LONG RANGE PLANNING COMMITTEE - SUTTER ROAD REALIGNMENT EXHIBIT

MAY 2023

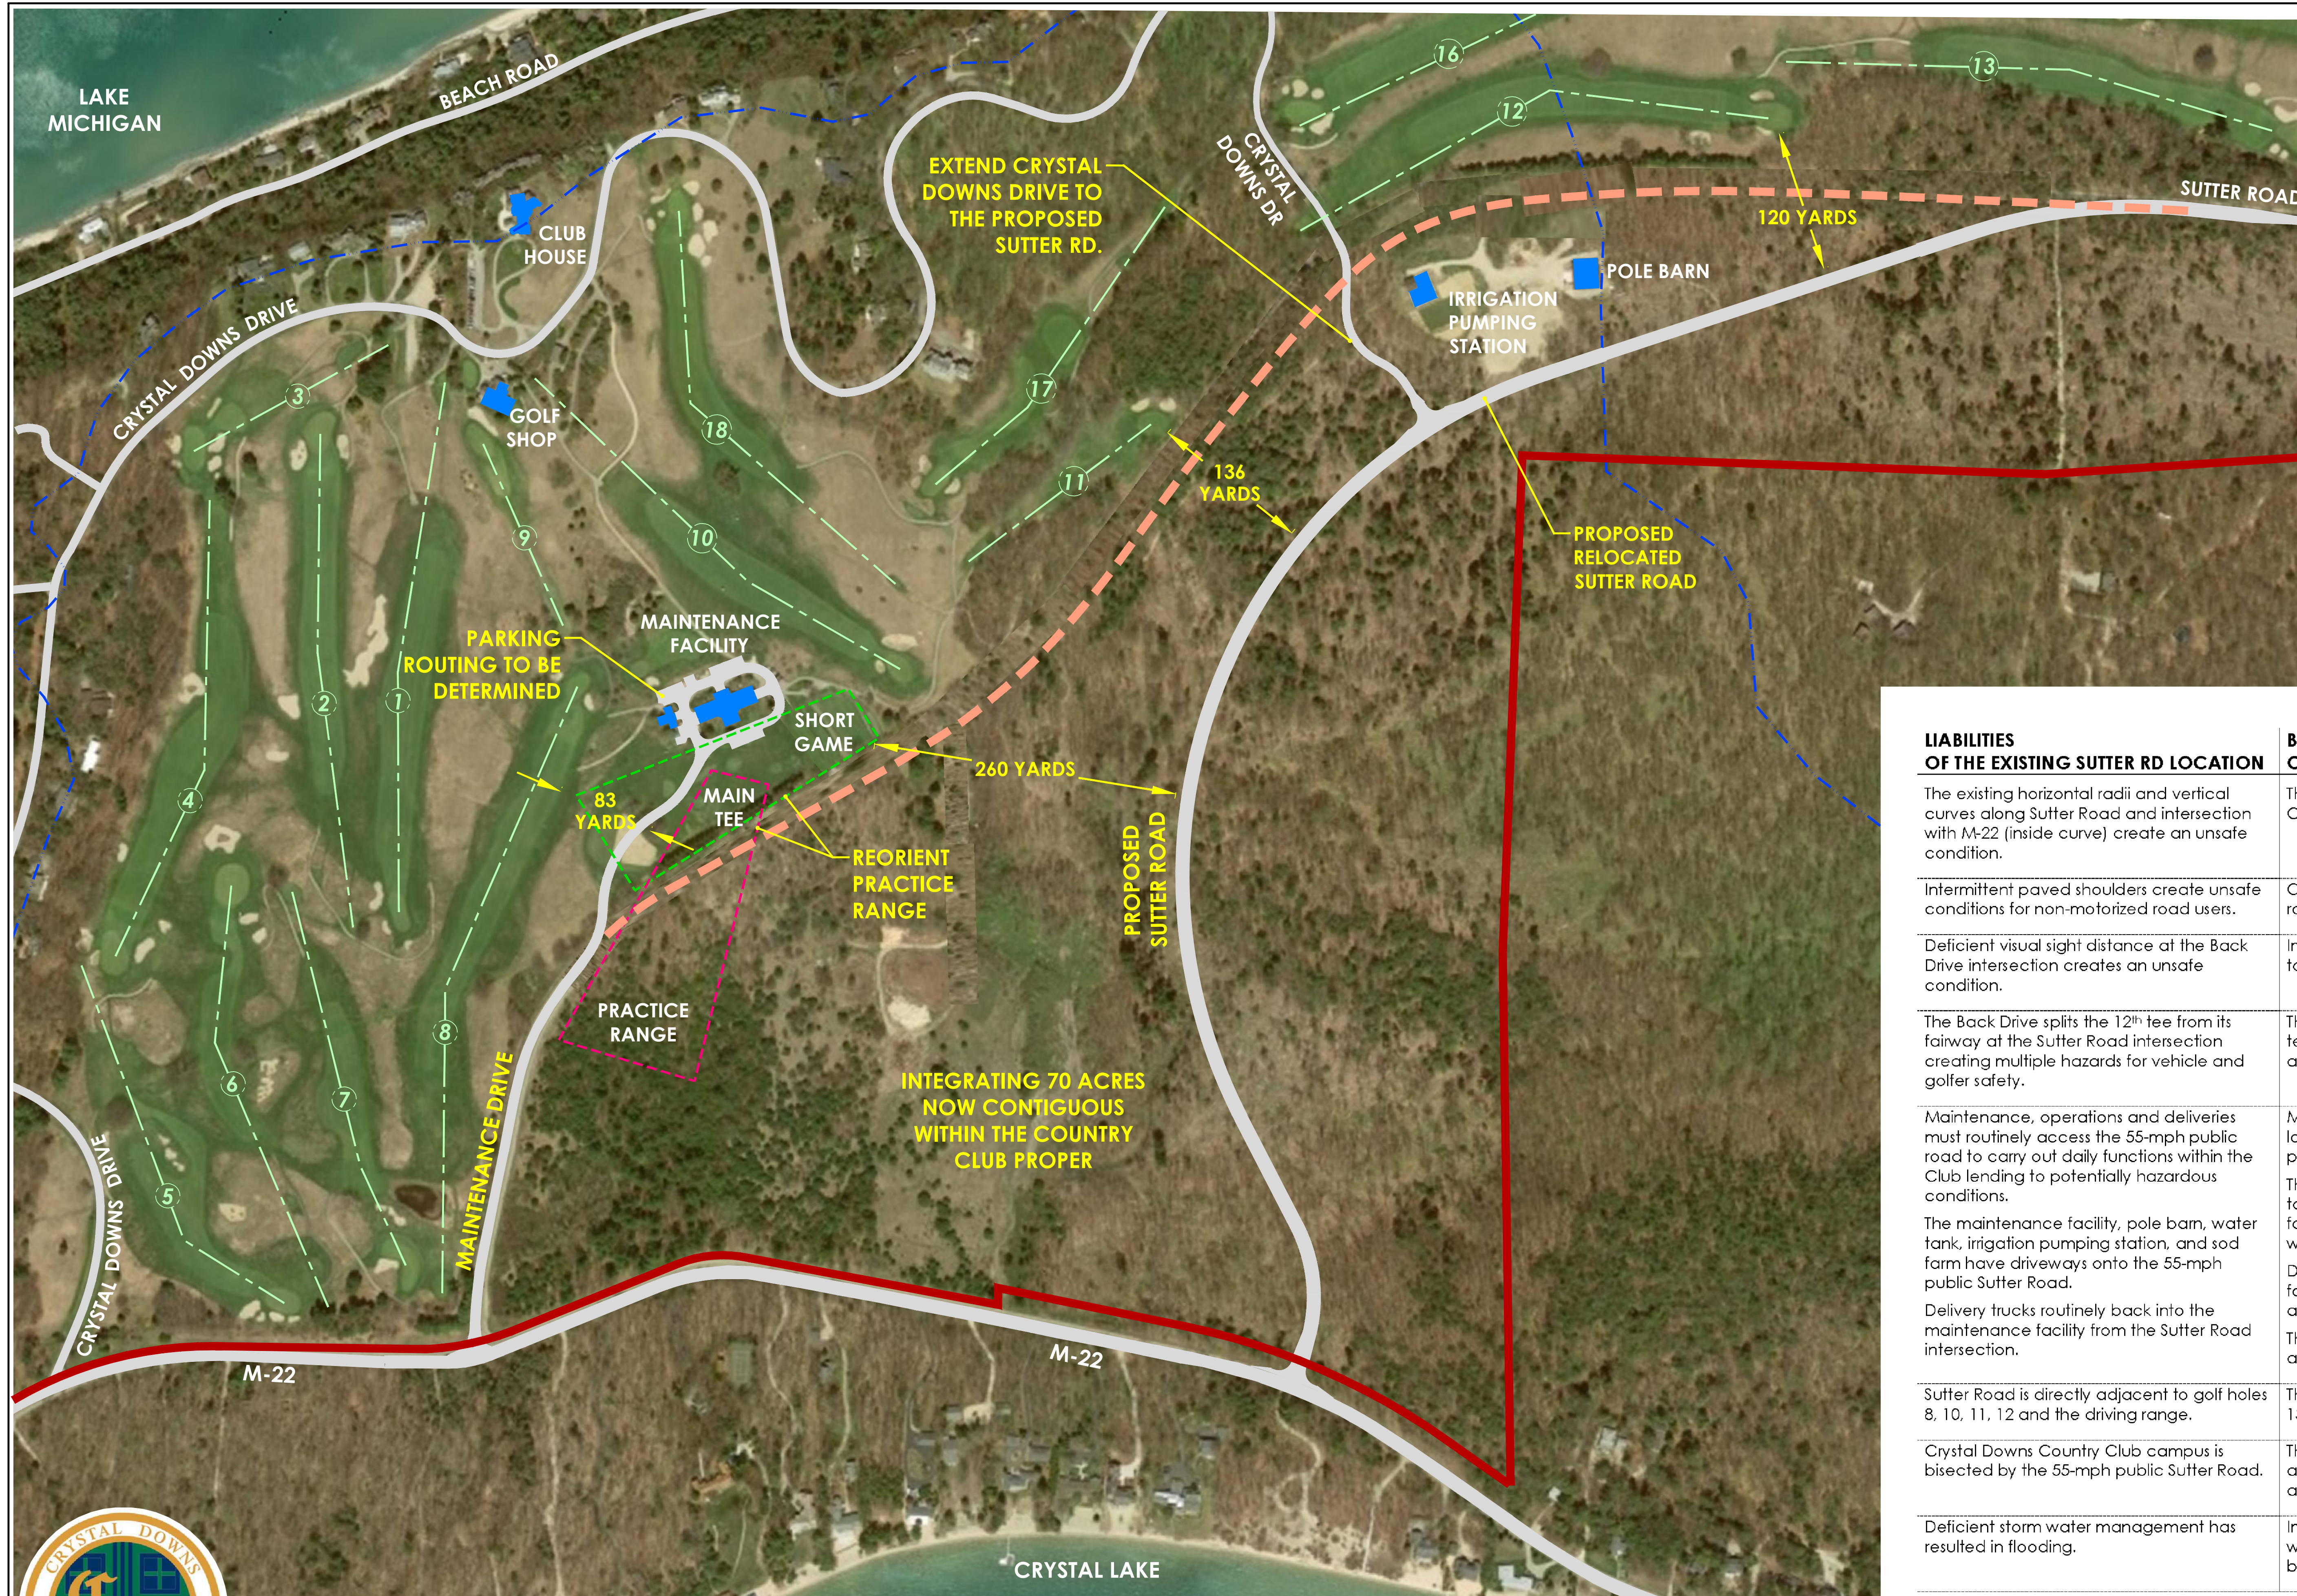
LIABILITIES OF THE EXISTING SUTTER RD LOCATION

- The existing horizontal radii and vertical curves along Sutter Road and intersection with M-22 (inside curve) create an unsafe condition.
- Intermittent paved shoulders create unsafe conditions for non-motorized road users.

- Deficient visual sight distance at the Back Drive intersection creates an unsafe condition.
- The Back Drive splits the 12th tee from its fairway at the Sutter Road intersection creating multiple hazards for vehicle and golfer safety.

- Maintenance, operations and deliveries must routinely access the 55-mph public road to carry out daily functions within the Club leading to potentially hazardous conditions.

- The maintenance facility, pole barn, water tank, irrigation pumping station, and sod farm have driveways onto the 55-mph public Sutter Road.
- Delivery trucks routinely back into the maintenance facility from the Sutter Road intersection.

- Sutter Road is directly adjacent to golf holes 8, 10, 11, 12 and the driving range.
- Crystal Downs Country Club campus is bisected by the 55-mph public Sutter Road.

- Deficient storm water management has resulted in flooding.

BENEFITS OF PROPOSED SUTTER RD REALIGNMENT

- The new Sutter Road will be designed to County Road standards for safety.
- Consistent paved shoulders provide more room for non-motorized road users.

- Improved Back Drive intersection designed to County Road Standards for safety.
- The Back Drive is rerouted behind the 12th tee, improving safety for member access and golfer experience.

- Maintenance, operations, and deliveries no longer have to enter onto a high-speed public road to perform daily functions.
- The maintenance facility, pole barn, water tank, irrigation pumping station, and sod farm are all accessed from private roads within the Club.

- Delivery trucks access the maintenance facility on a private road designed to accommodate large trucks.
- The delivery receiving area is relocated away from the driving range.

- The Sutter Road realignment will provide a 135-yard+ buffer from the golf course.
- The Sutter Road realignment will result in an additional 70-acres of contiguous common area within the Country Club proper.

- Improved storm water management design will include best practices management bio retention and rain gardens.
